CASE STUDY

Six years of effluent water subsurface drip irrigation (SDI) on a Jojoba plantation, using Metzerplas Adi dripper with Rootguard® Technology (RT) *G. Sagi Eco-Stream - Water & Environment, gsagi@zahav.net.il*

The Galon case study:

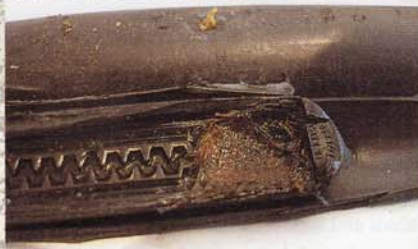
Figure 1: A dripper without RT blocked by root intrusion, clogging the emitter's outlet and the inner water passageway.

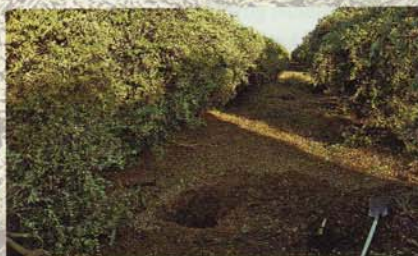
Figure 2: The Jojoba plantation irrigated with SDI using Adi (Metzerplas) 3.5 L/h dripper impregnated with Treflan™ by RT.

Thirty hectares of the Jojoba plantation of Kibbutz Galon were irrigated with SDI, using 3.5 L/h Adi (Metzerplas) drippers, 1m spacing, with RT. The driplines were installed 6 years ago (April 2000) at a depth of 35 cm. Secondary treated effluent water, stored in an irrigation reservoir and filtered by a 120 mesh automatic screen filter were used to irrigate the plantation at an average amount of 3,500 m³/Hectare/year. The SDI at the Galon plantation kept the soil surface dry and free of weeds (Figure 2) even though each irrigation period

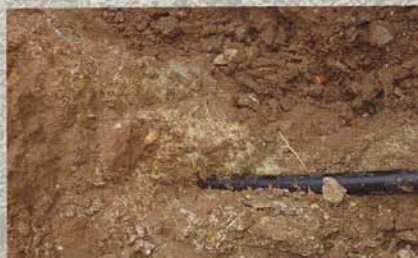
Figure 3: Root zone development around and along the dripline but not in proximity to the drippers

was longer than 24 hours of watering. During the seven irrigation seasons that this SDI system has been operating the flow rate has remained stable with no dripper blockage due to either water quality causes or root intrusion. Excavation and exposure of the SDI pipelines show an abundance of roots around and along the dripline (Figure 3), but no roots were developed in the soil adjacent to the emitters (Figure 4) or in the dripper outlet. A detailed examination of the drippers themselves indicated that the emitter outlet and the entire water passageway of the dripper, including the inlet filter, remained significantly free of any root intrusion or accumulation of clogging matter, such as organic or inorganic particles, chemical precipitates or biofilm development (Figure 5).

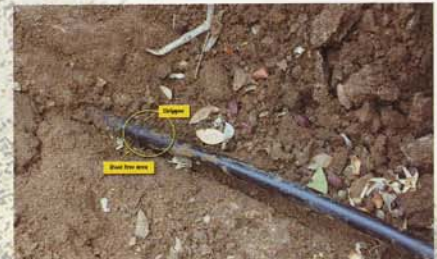
Figure 4: The soil adjacent to the dripper is clear of root development.
